Calcified Silicone Granulomas after Breast Augmentation; an Increased Risk of Rupture?

Department of Plastic Surgery, Aalborg University Hospital, Soendre Skovvej, Aalborg, Denmark

Cite This Article: Liv Schollhammer, and Kira Lundin, "Calcified Silicone Granulomas after Breast Augmentation; an Increased Risk of Rupture?" *American Journal of Medical Case Reports* 2, no. 1 (2014): 16-18. doi: 10.12691/ajmcr-2-1-5.

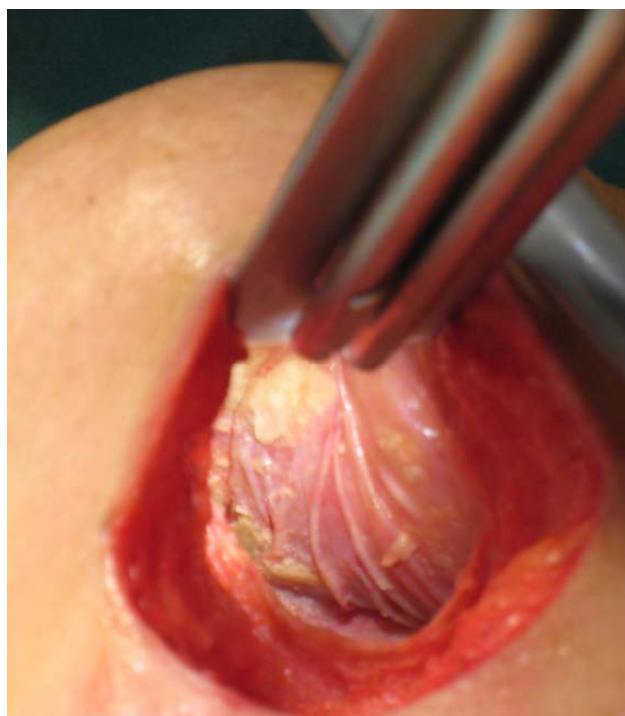
Figure 1. Multiple brittle calcifications seen on the inside of the fibrous capsule

As described in this commentary, both women presented calcified granulomas in the fibrous capsule formed around the old implants. In both cases the patients had not had breast implants prior to the ones removed at our department and the source of the CSG is believed to have been implant rupture [2].

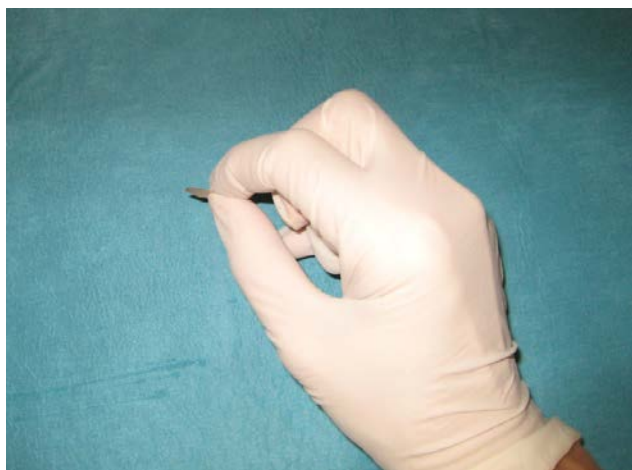
Figure 2. The brittle calcification after removal from the fibrous capsule

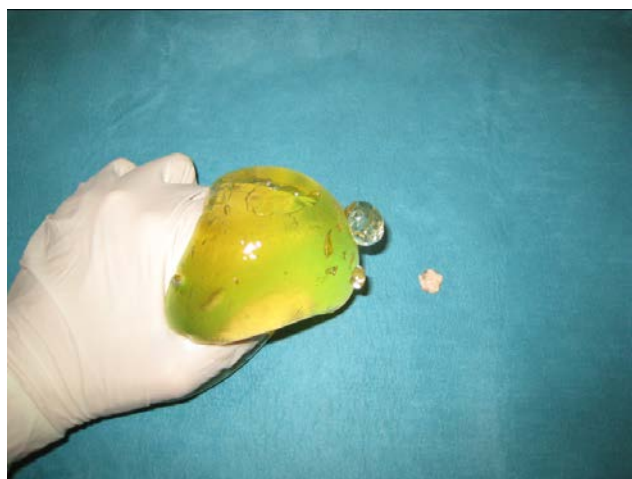
Figure 3. The brittle calcification cuts easily into the old implant and silicone leaks out

When tested, the sharp edges of the calcified granuloma were easily able to cut into the implants. This made us question whether CSG could play a role in implant rupture? Thus; if left in a breast after an exchange of implants could CSG potentially damage and ultimately rupture a new implant? When comparing with other causes of implant rupture, CSG potentially damaging effect may most likely only play a minor role in implant rupture but is surgically preventable. Even with the advances in durability of implants, rupture and granuloma formation is still a concern. A case report by Lahiri et al describes locoregional silicone spread after high cohesive gel implant rupture with silicone granuloma formation in capsule [9].

With this case report, we seek to raise awareness of this potential complication and the possible benefits of capsulectomy including all calcified elements when replacing silicone breast implants. We suggest that further studies be made to shed light upon this potential complication in order to improve surgical techniques as well as patient information.
